***Field Test Report***  
***for***  
***CHARTS***

***Contract Number: DACW42-01-C-0023***

**Prepared For:**  
Joint Airborne Lidar Bathymetry  
Technical Center  
of Expertise

**Prepared By:**  
Optech Incorporated  
Marine Survey Division  
100 Wildcat Road  
Toronto, Ontario  
Canada M3J 2Z9

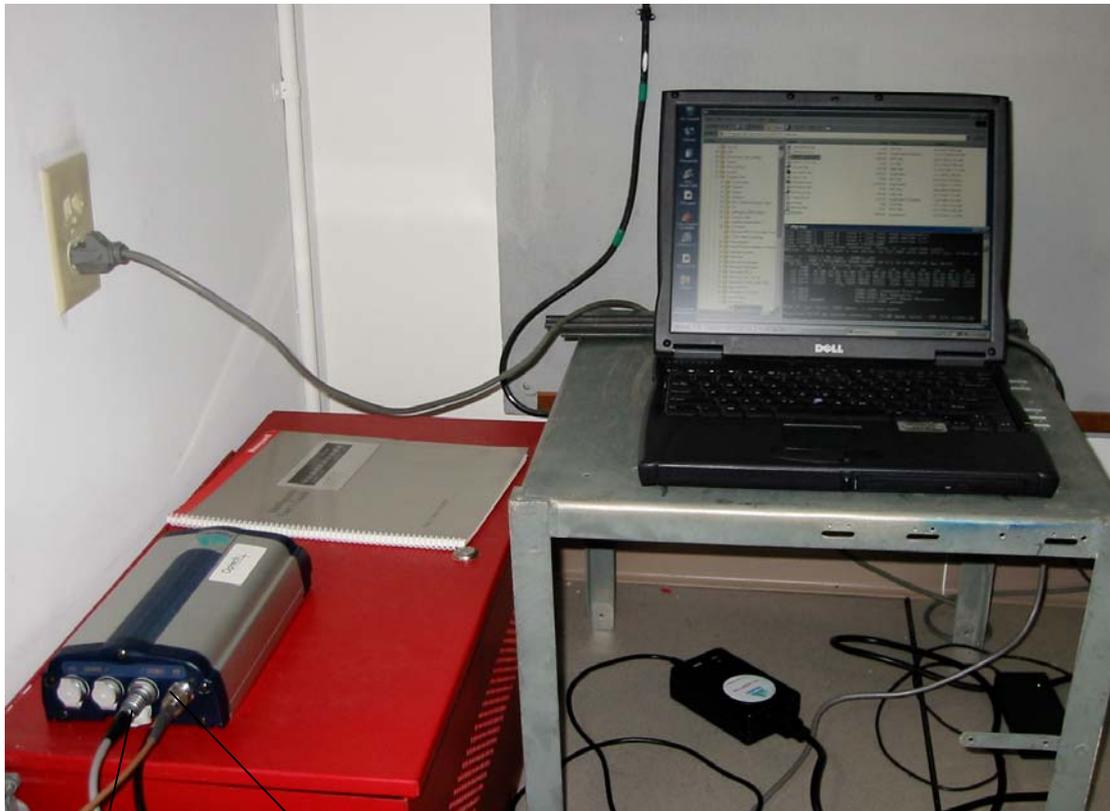
**Figure 3: GPS Base Station**

Cable to NovAtel 512 GPS antenna, located on SFTF building roof.

Data link from NovAtel PROPAK II GPS receiver to Laptop - COM1

A GPS base station was set up at the South Florida Test Facility (SFTF) building for most of the CHARTS kinematic GPS (KGPS) data processing during the field trials. The above figure shows the hardware arrangement, a NovAtel PROPAK II dual-band receiver and a laptop to collect ground-based GPS data.

The coordinates for the base station were calculated by post-processing about 17 hours of its data acquired on August 4, 2003, with three nearby CORS GPS base stations as reference (results provided by Richard Barker, Fugro Chance Inc.).

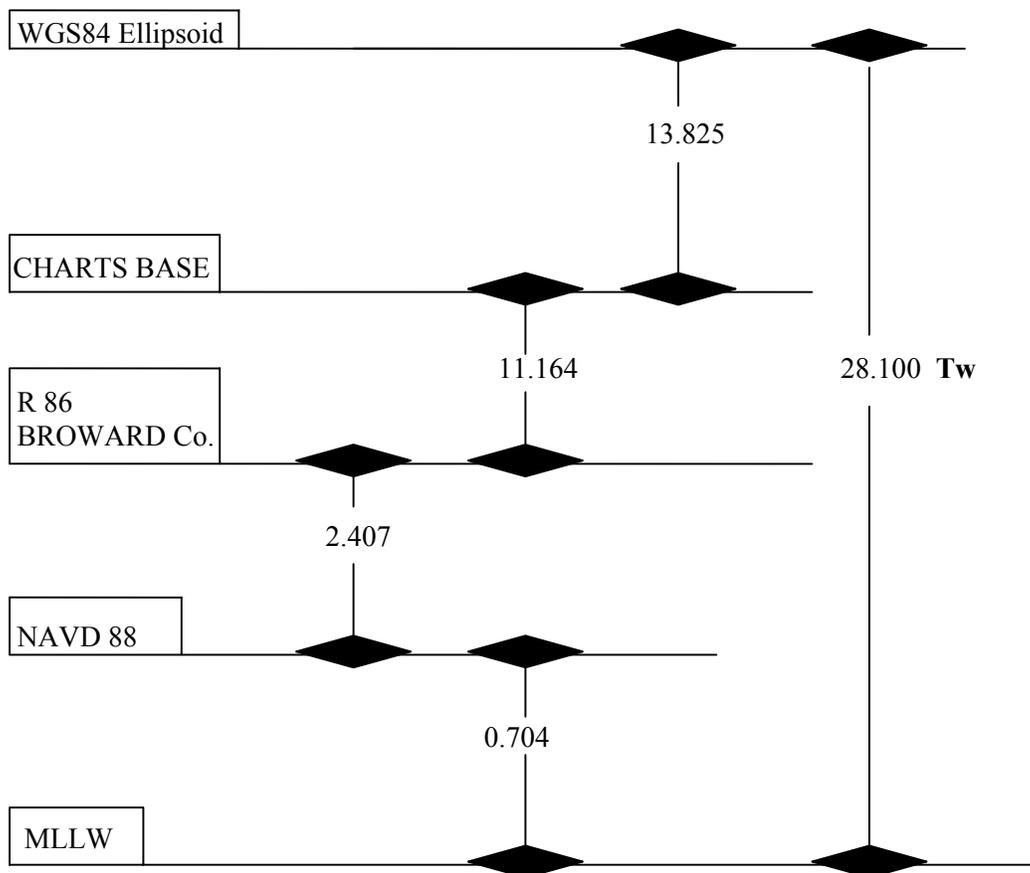
**Figure 4: Corrections From WGS 84 To MLLW (All Heights In Meters)**

<b>Dania</b> NAVD 88 to MLLW	<b>m</b> 0.623	<b>ft</b> 2.04 based on South Dania Sound NOS Benchmark Publication, Station 8722971
<b>Port Everglades</b> NAVD 88 to MLLW	<b>m</b> 0.704	<b>ft</b> 2.31 approximation based on published sheets from locations south and north of Port Everglades
<b>Monuments S 314</b>	<b>m</b> 2.449	<b>ft</b> 8.03 NAVD 88
<b>Monuments R 86</b>	<b>m</b> 2.407	<b>ft</b> 7.90 results from leveling based on S 314 control
<b>CHARTS Base</b>	<b>m</b> -13.825 WGS84 El Ht., from Richard Baker's GPS processing -12.182 NAD83 El Ht., from Richard Baker's GPS processing 13.547 NAVD 88 Ortho Ht., from Richard Baker's GPS processing	
<b>R 86 Broward Co.</b>	<b>m</b> -24.989 WGS84 EL Ht. -23.346 NAD83 EL Ht. 2.383 2.407 -0.024 NAVD88 ht., (GPS – levels = diff.) will use leveling results 3.111 MLLW Ht., (based on levels and approx. NAVD88 – MLLW correction) -28.1 WGS84 El to MLLW	
	<b>Current T</b> -27.961	<b>New T</b> -28.100

<b>Diff.</b> 0.139 difference based on NAVD 88 calculations

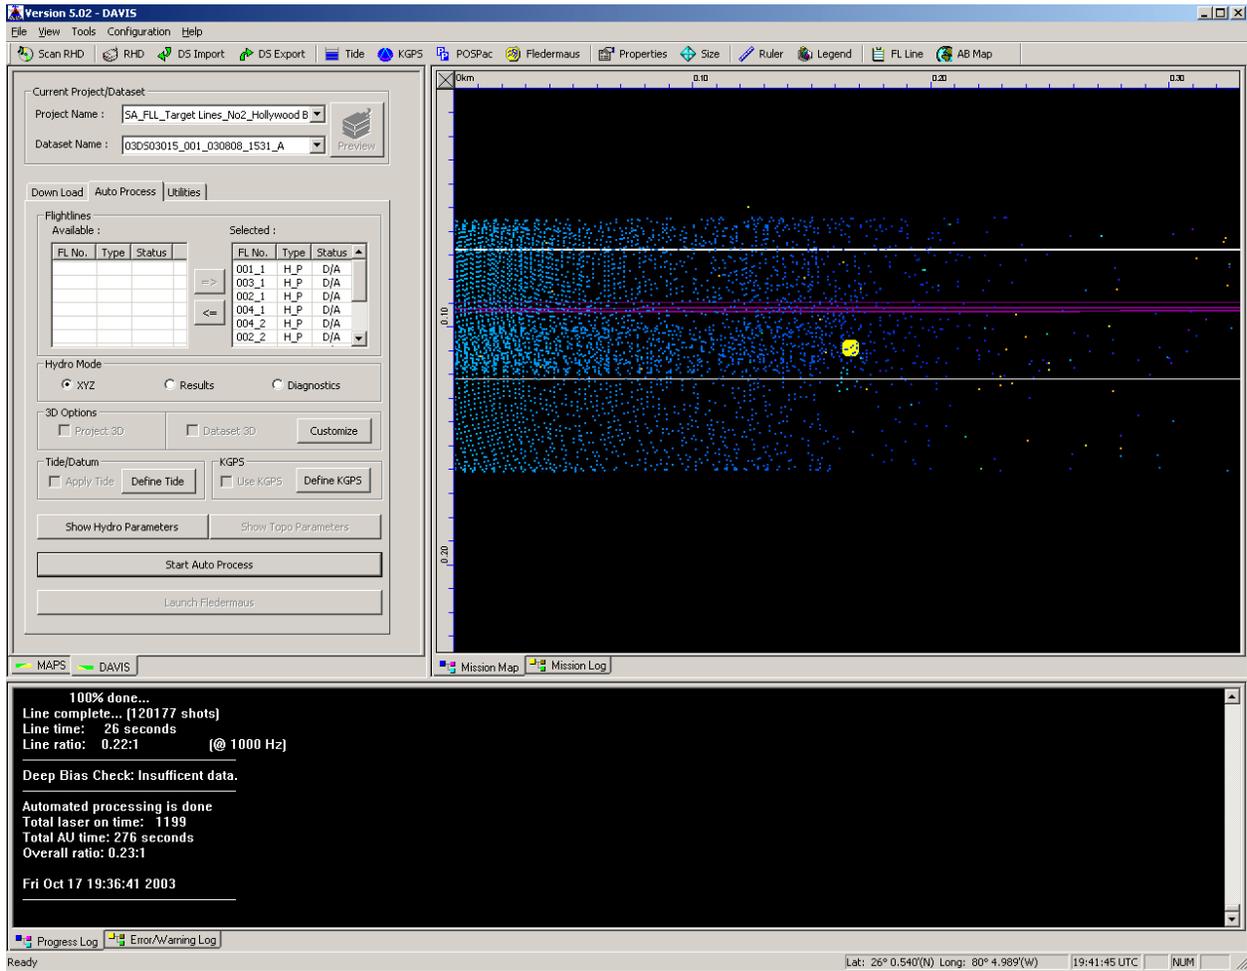
Figure 5: DAVIS Window For Extinction Flightlines Of August 8, 2003

$$K_d \cdot \text{depth} = 0.08 \text{ m}^{-1} \cdot 39.40 \text{ m} = 3.152$$

Three flightlines were flown and analyzed for depth penetration capability. The flightlines were flown from deep to shallow and from shallow to deep water. The extinction depth was determined from the lidar data by inspecting the area where the lidar depths started to become sparse.

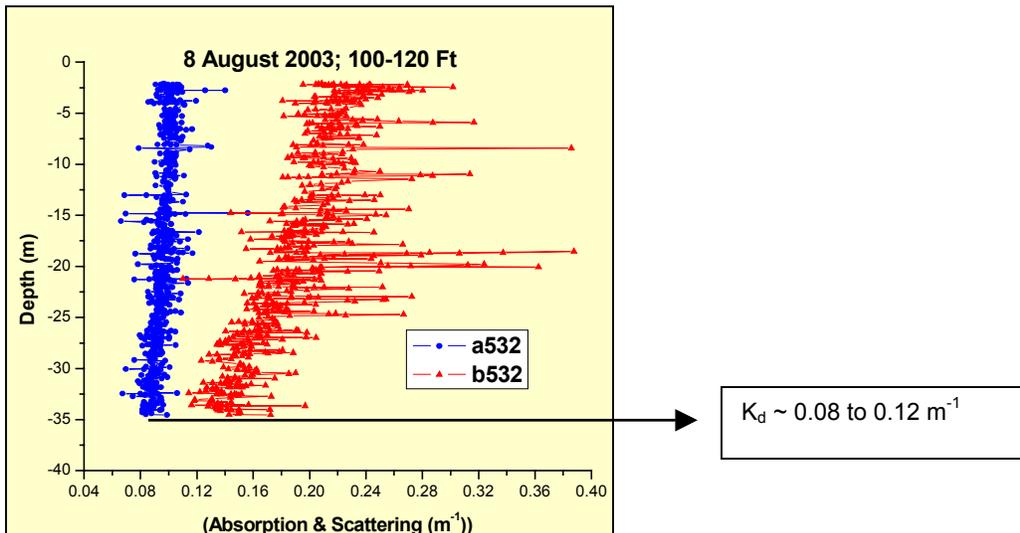
**Figure 7: Absorption And Scattering Measurements**

Dr. Alan Wiedemann of the Naval Research Laboratory (NRL) took simultaneous measurements of various water parameters. Included in these measurements was the diffuse attenuation coefficient, which is the value used below. An example of this measurement is shown in the figure below.

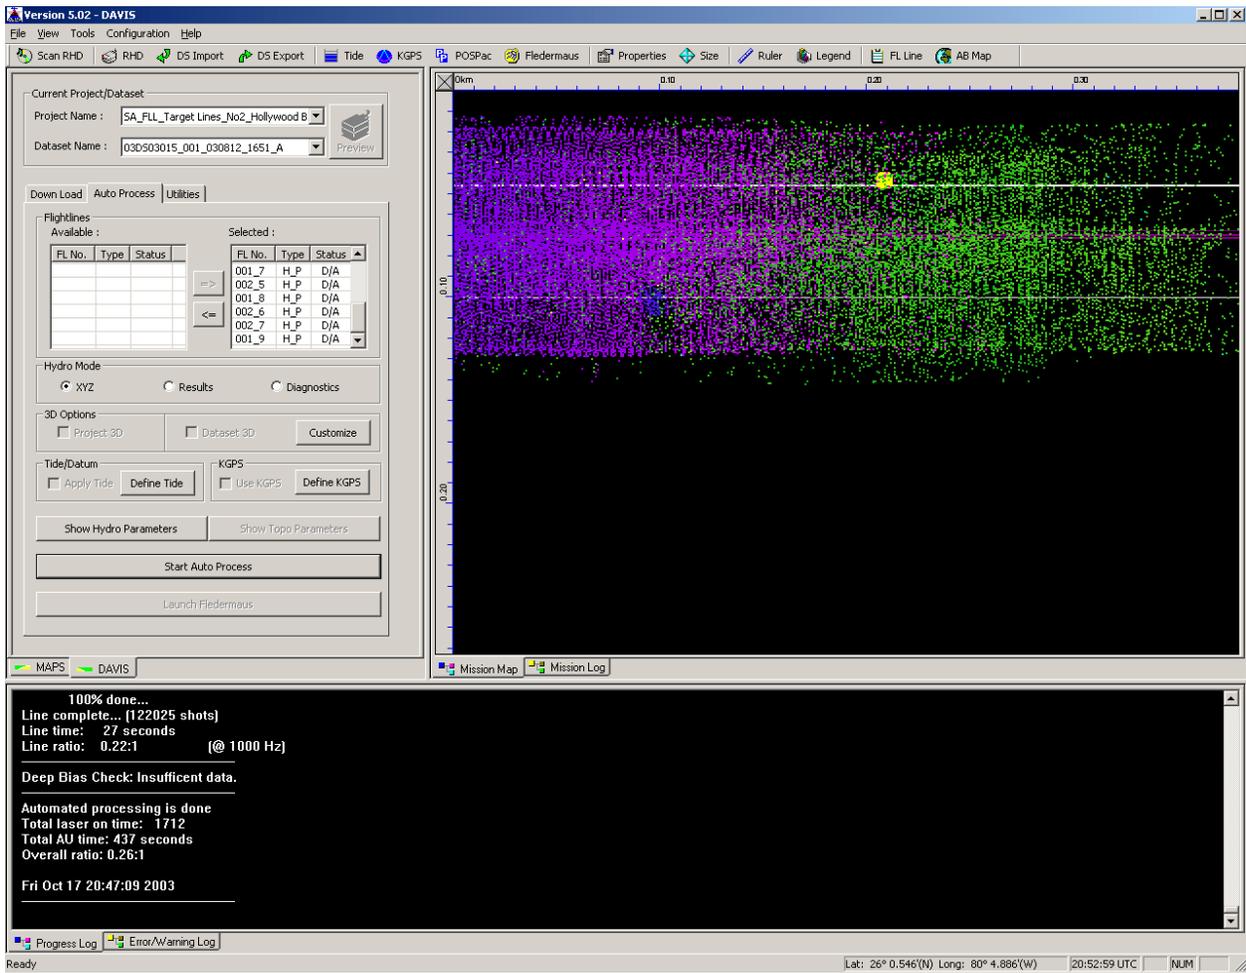
**Figure 8: DAVIS Window For Extinction Flightlines On August 12, 2003**

$$K_d \cdot \text{depth} = 0.1 \text{ m}^{-1} \cdot 44.45 \text{ m} = 4.445$$

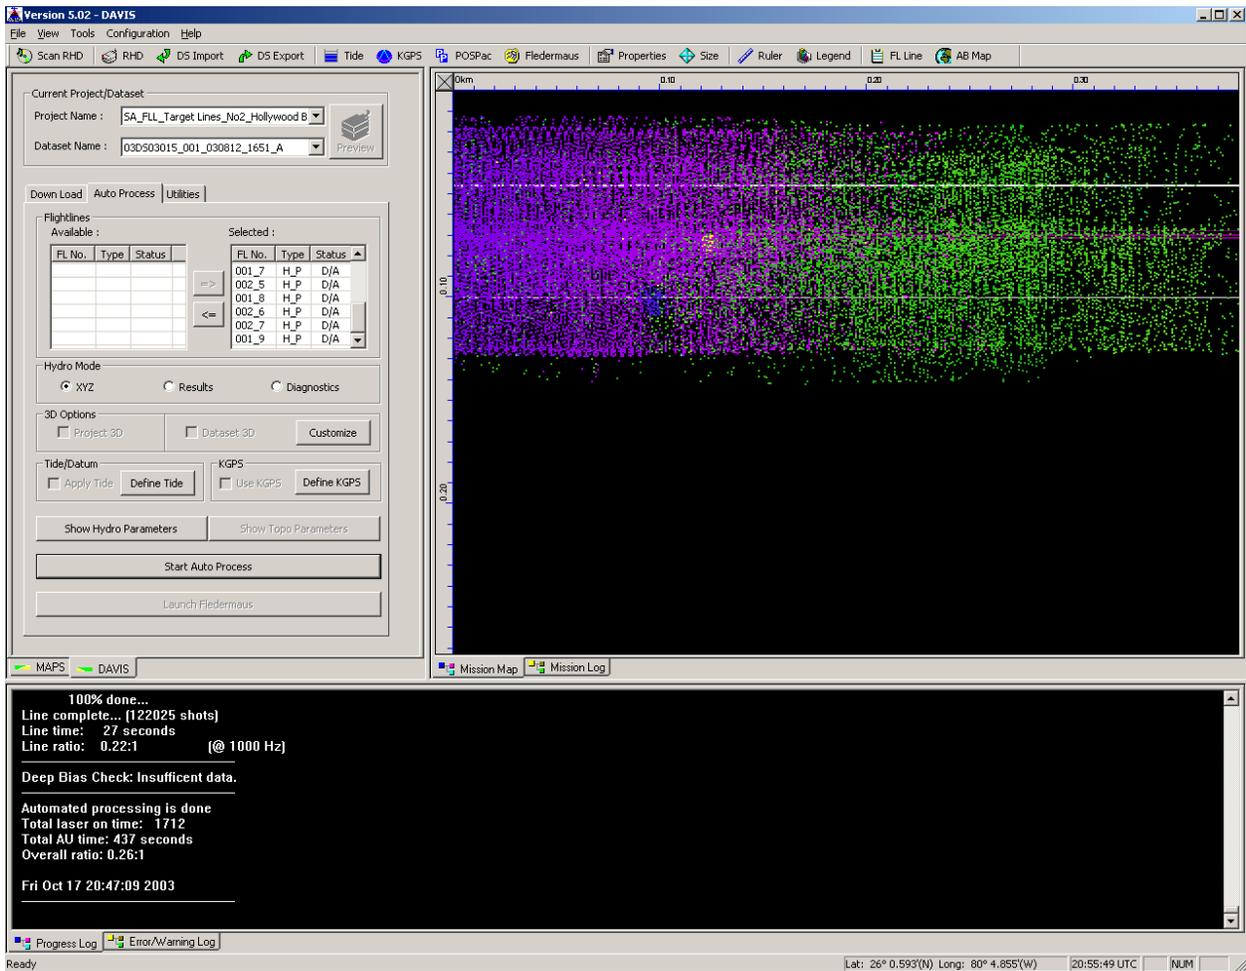
**Figure 11: DAVIS Window For Extinction Flightlines Of August 12, 2003**

$$K_d \cdot \text{depth} = 0.1 \text{ m}^{-1} \cdot 39.79 \text{ m} = 3.979$$

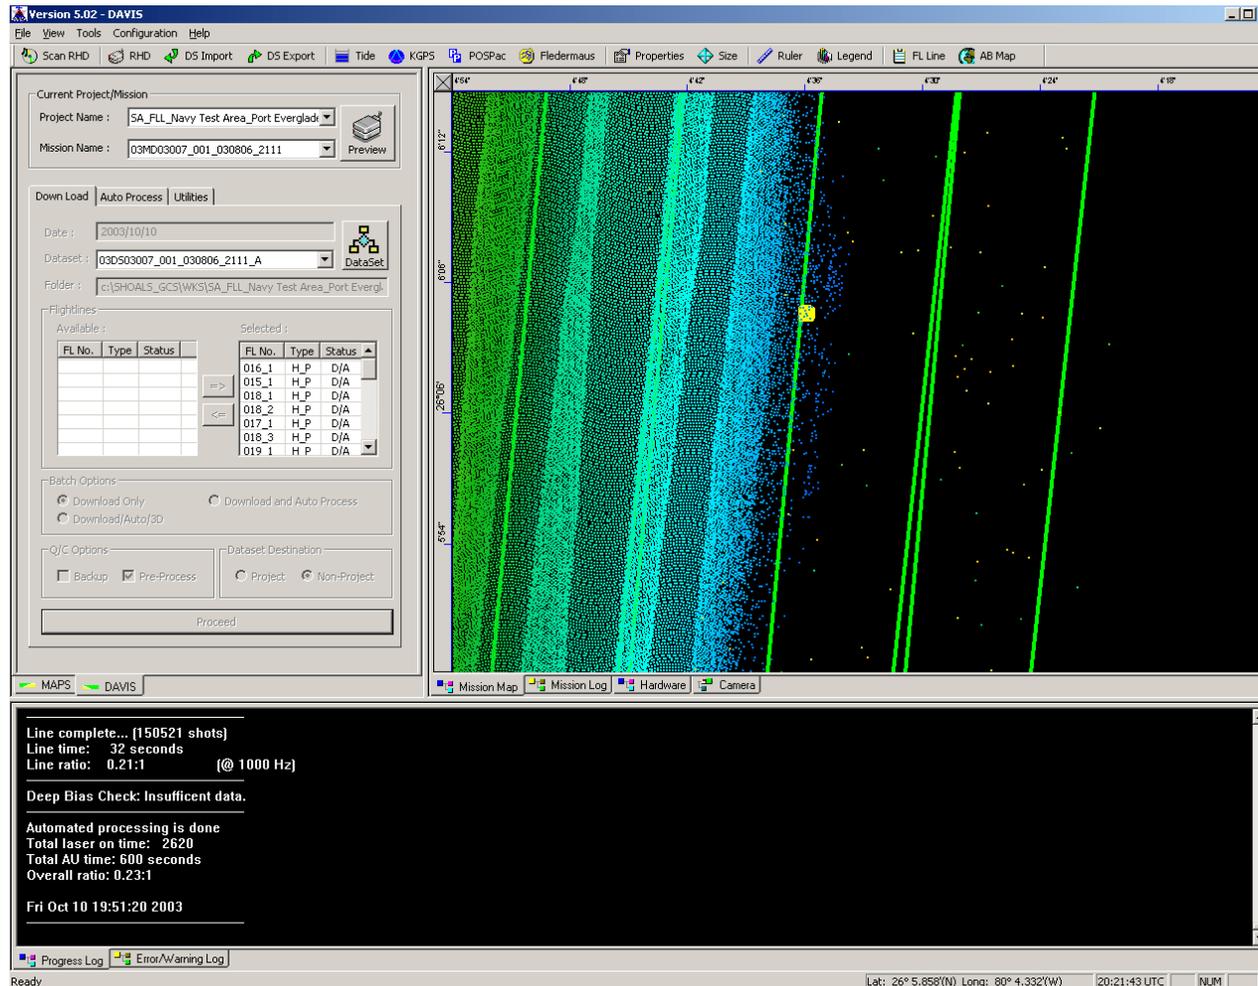
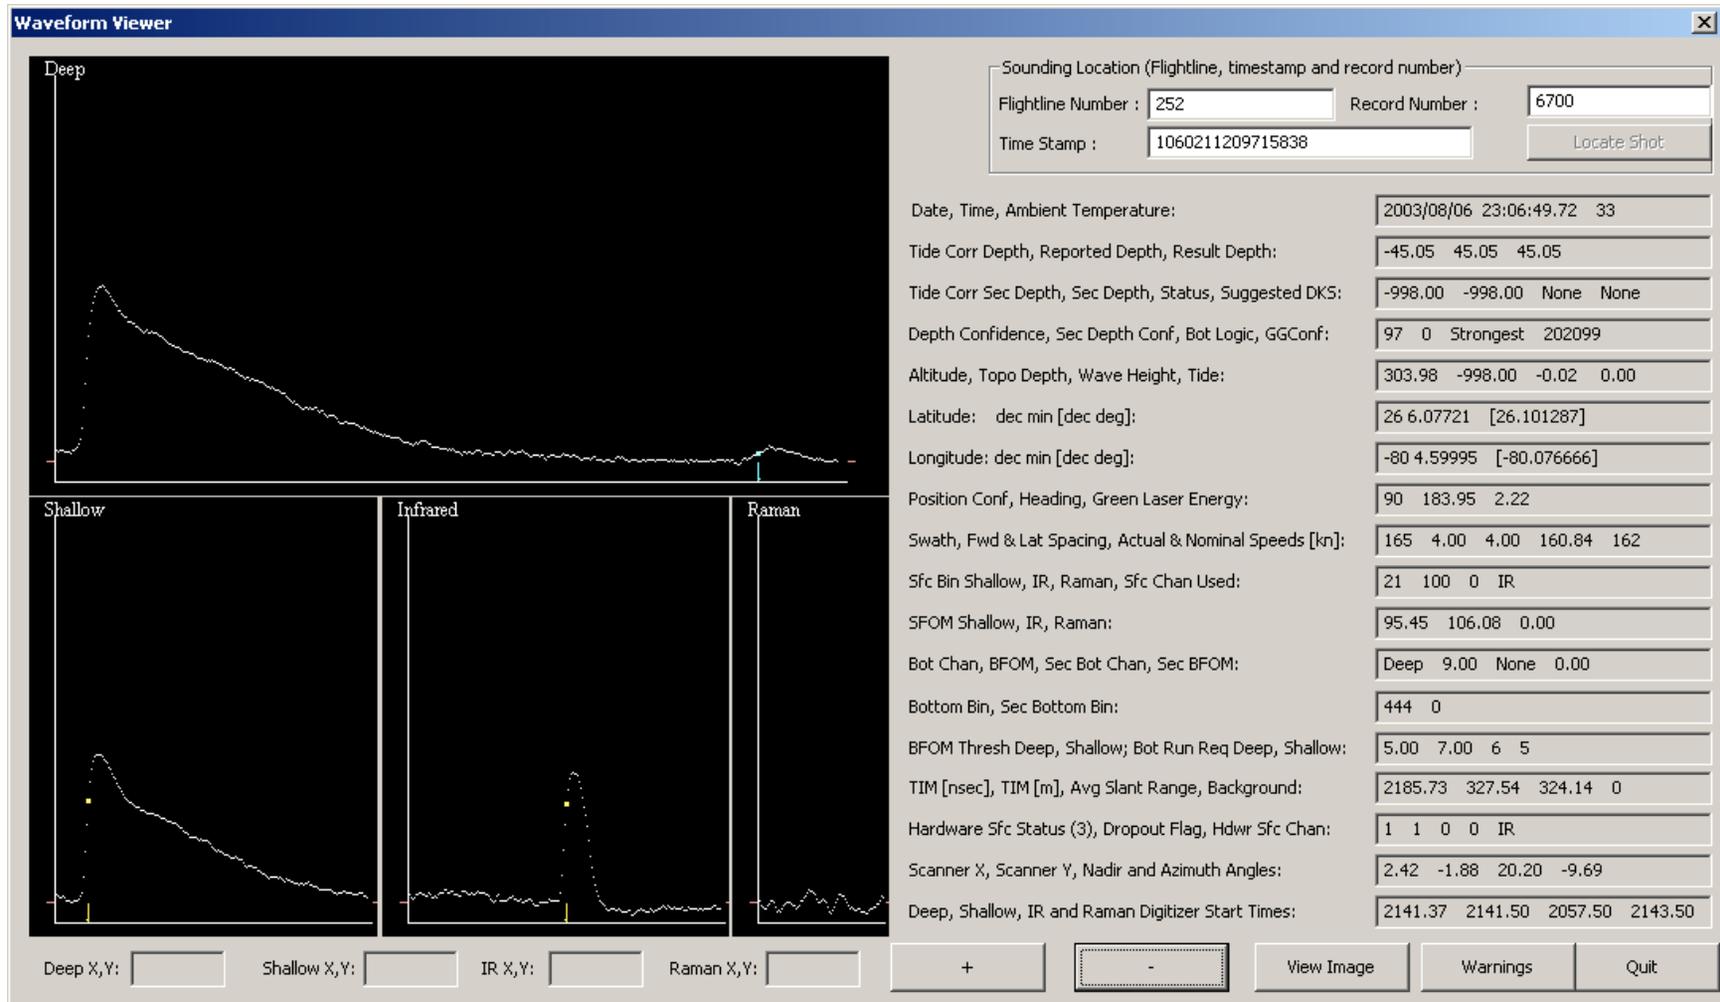
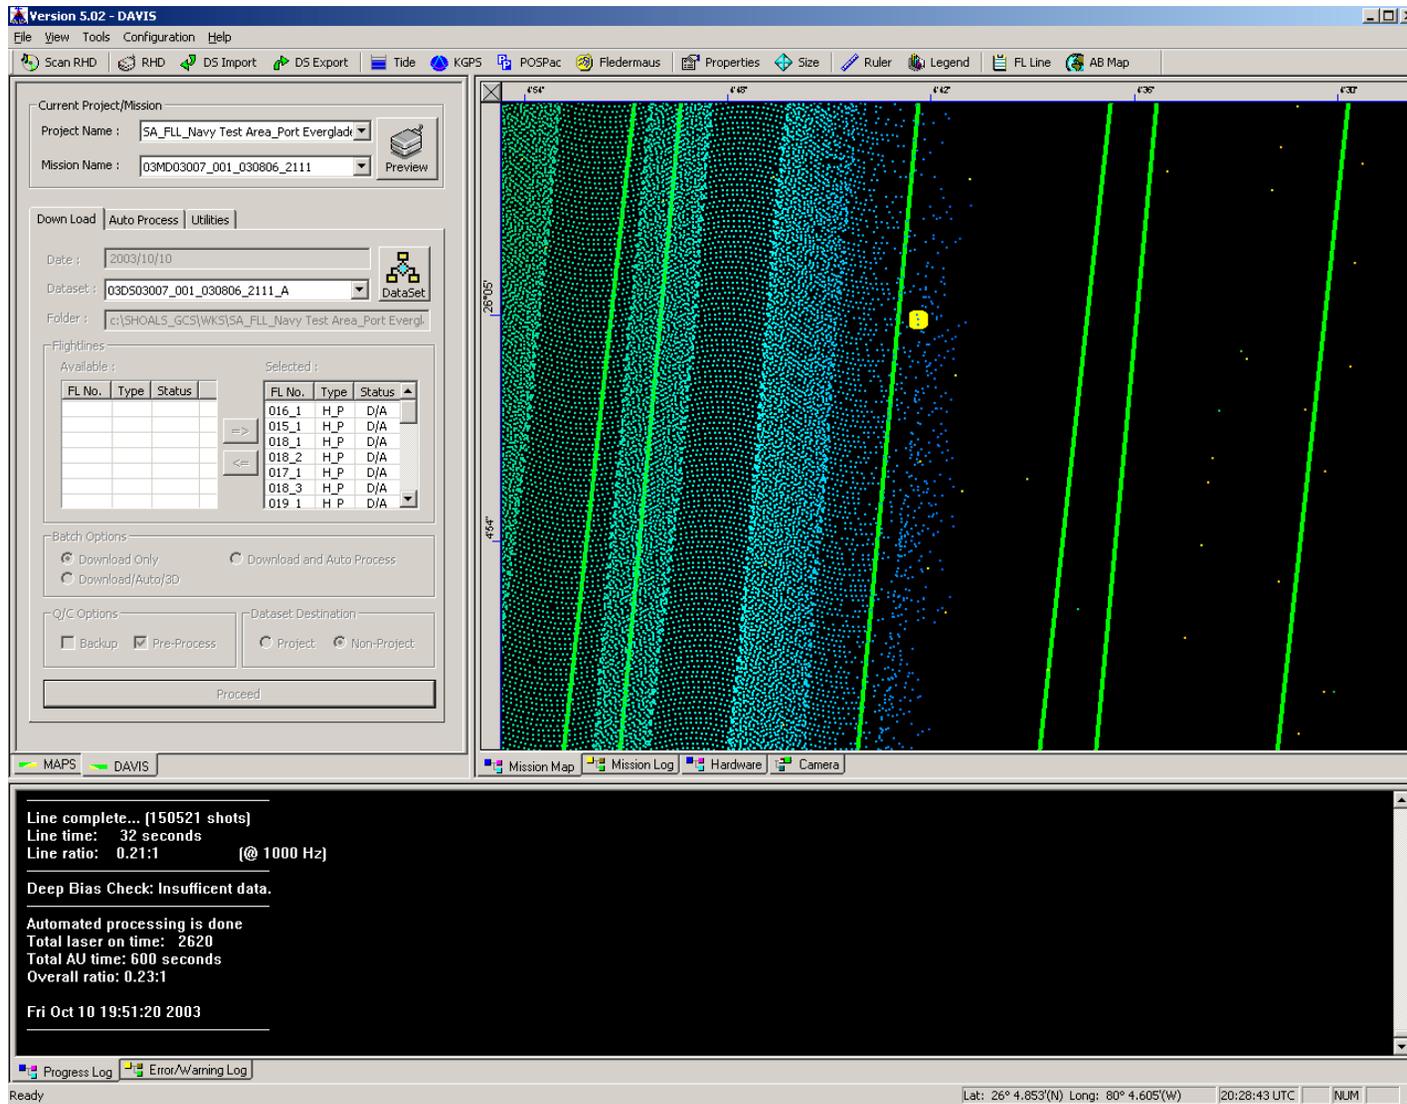
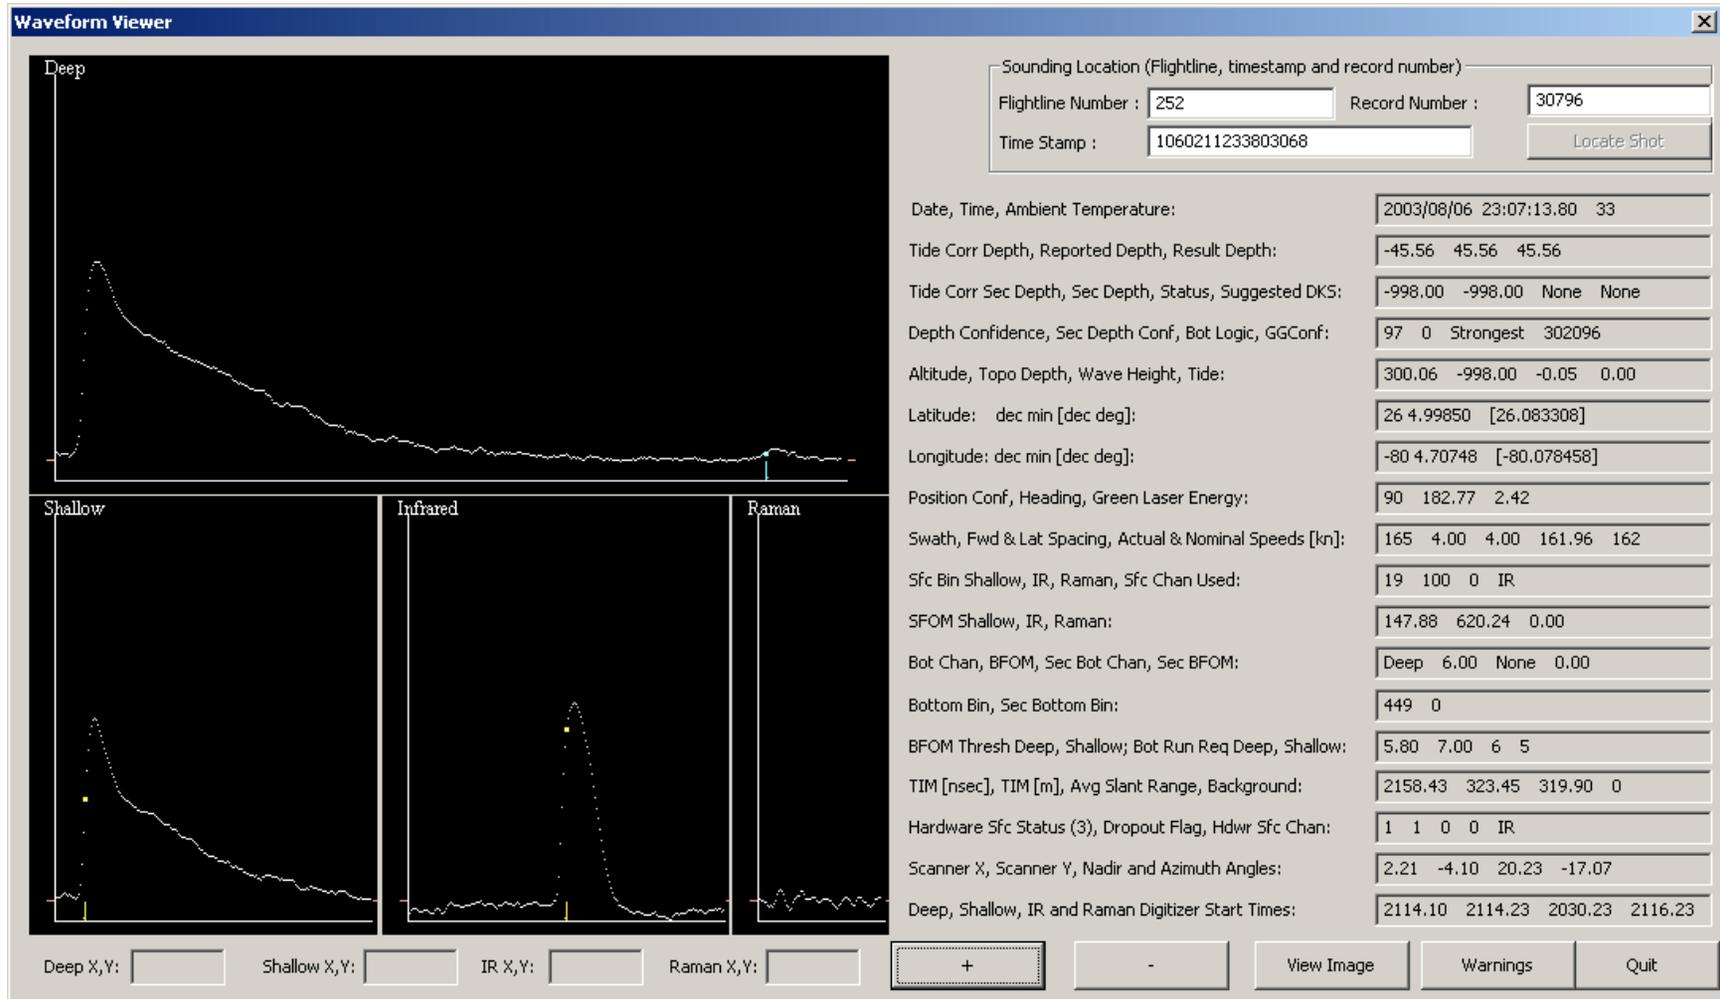
As shown in the following four figures, a maximum depth of 45 meters was detected at the Navy test site in Port Everglades.

Figure 14: Maximum Depth, Screen 1

Figure 15: Maximum Depth, Screen 2

Figure 16: Maximum Depth, Screen 3

Figure 17: Maximum Depth, Screen 4

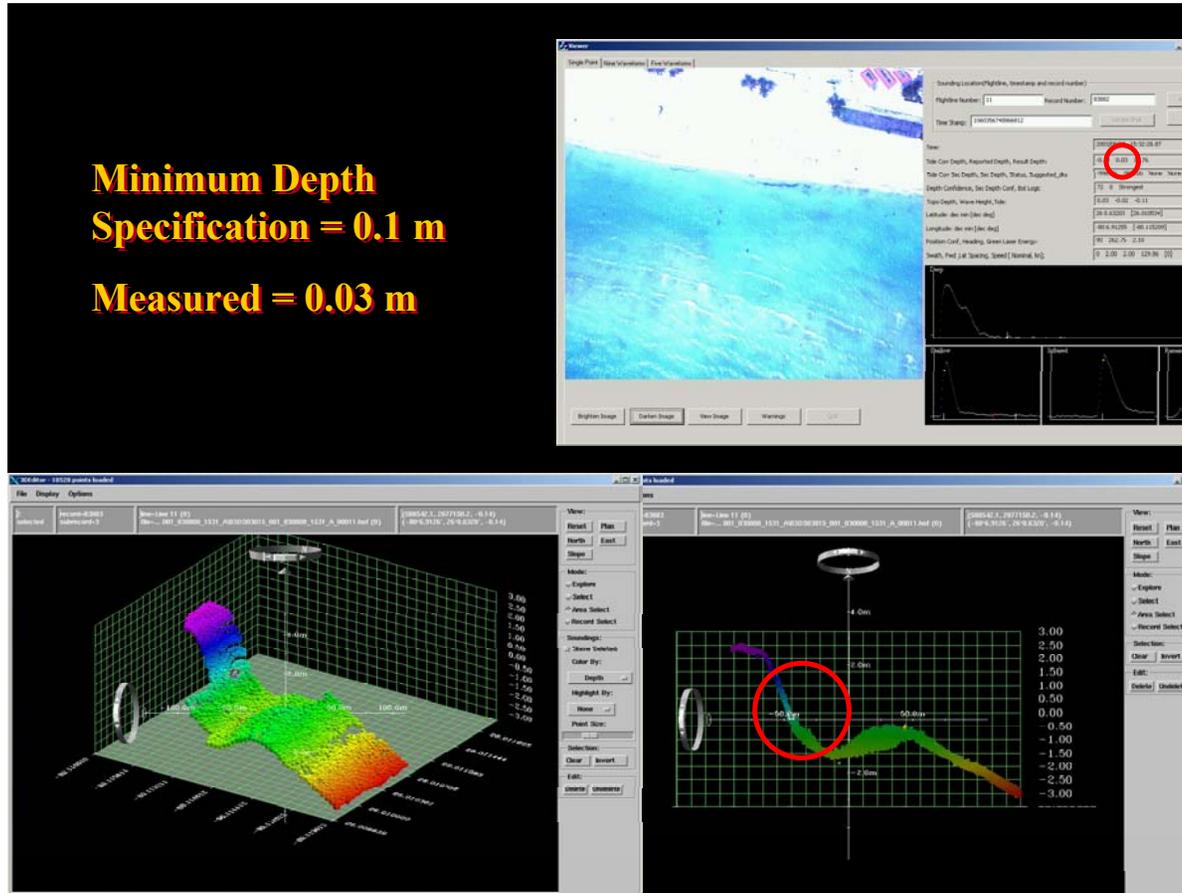
Figure 18: Minimum Depth - DAVIS Window

The shoreline depth swap utility was used near shore to enhance the coverage in the land/water interface zone. As illustrated in the figure below, the coverage is continuous from water up onto land.

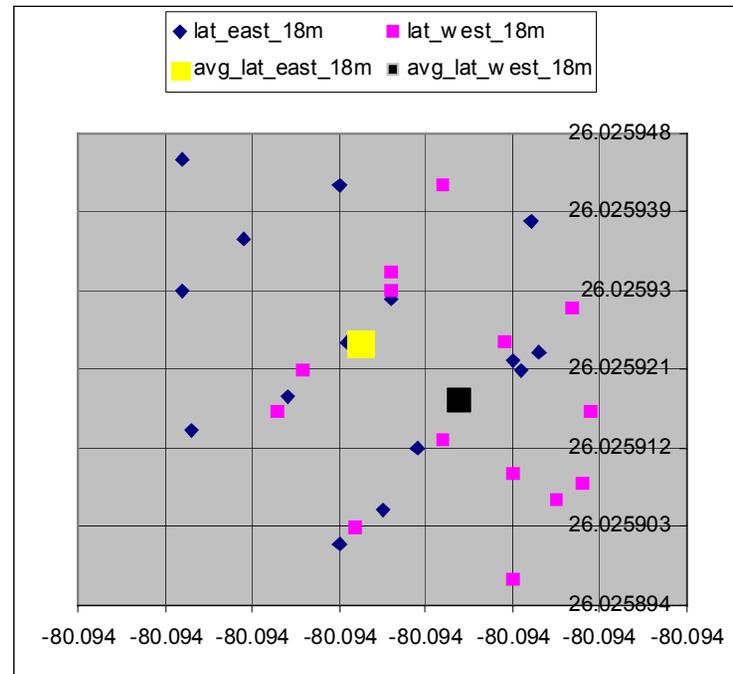
Figure 19: Results Of Sounding And Elevation Positional Accuracy

Figure 19 below illustrates the results of the test. The diamonds are lidar hits in the East direction; squares are lidar hits in the West direction. The large squares are the average position for the two directions. The grid consists of 1×1 m squares.

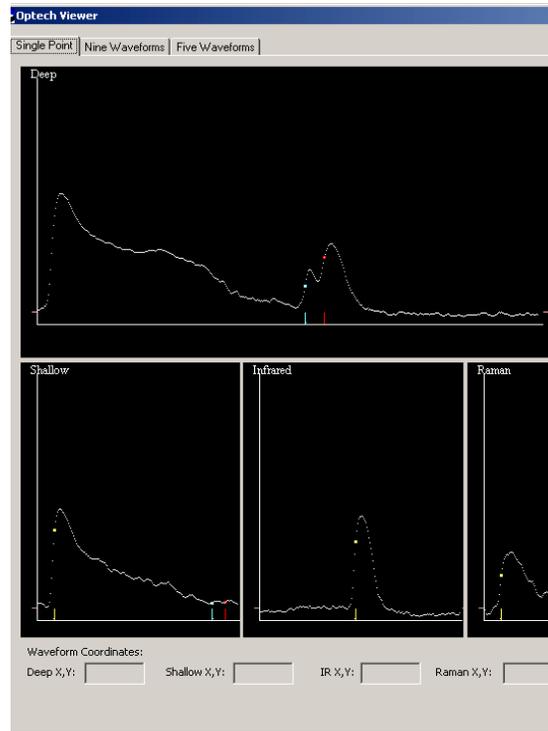
**Figure 20: Underwater Horizontal Position Accuracy Waveform**

The waveform in Figure 20 shows the resolved 26 m deep target and the 28 m bottom returns. The reported depths from the post-processor were 26.29 m and 28.39 m.

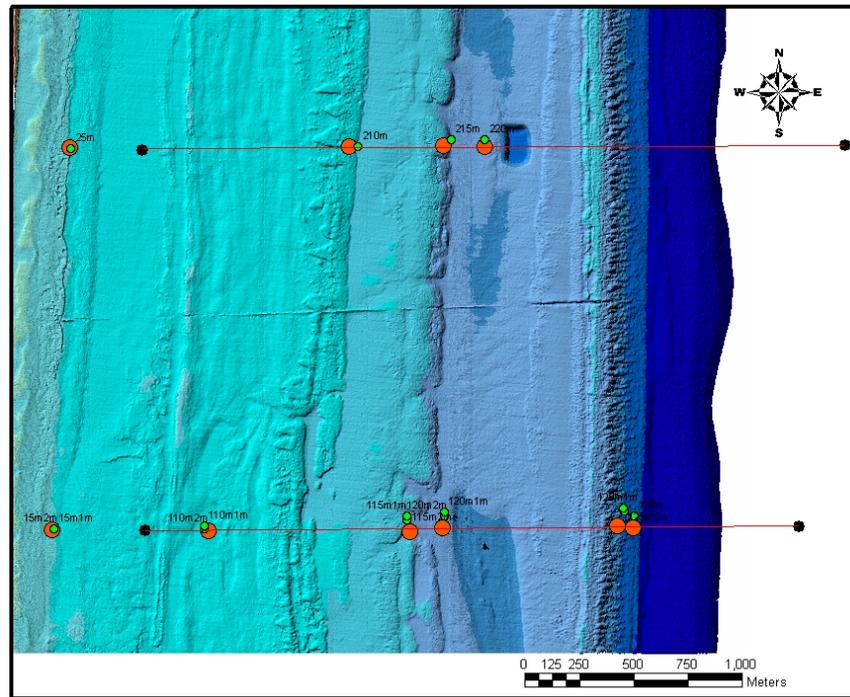
Figure 21: Target Placement

Figure 21 below shows the target placement.

This test determined how deep and under what conditions CHARTS could detect 2×2×2 m targets placed on the bottom. Table 6 below shows the preliminary results of target detection. It confirms that CHARTS detected all targets at all depths.

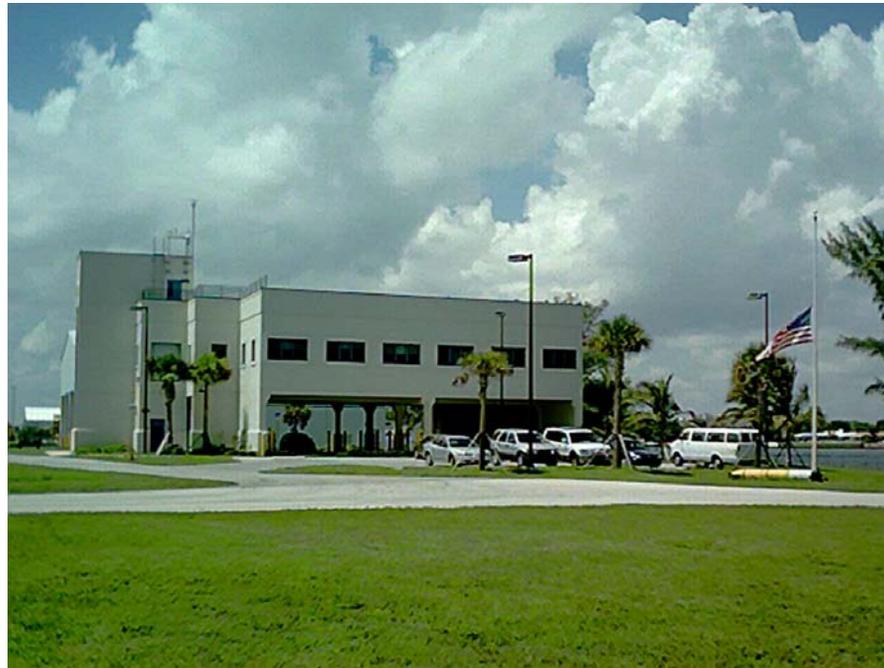
**Figure 22: US Navy South Florida Testing Facility (SFTF) Building**

Test data is discussed below. Missions were flown over the US Navy South Florida Testing Facility (Figure 22). GPS data was collected over the SFTF east side parking lot by Fugro Chance personnel, and used to generate the ground truth surface shown in Figure 23.

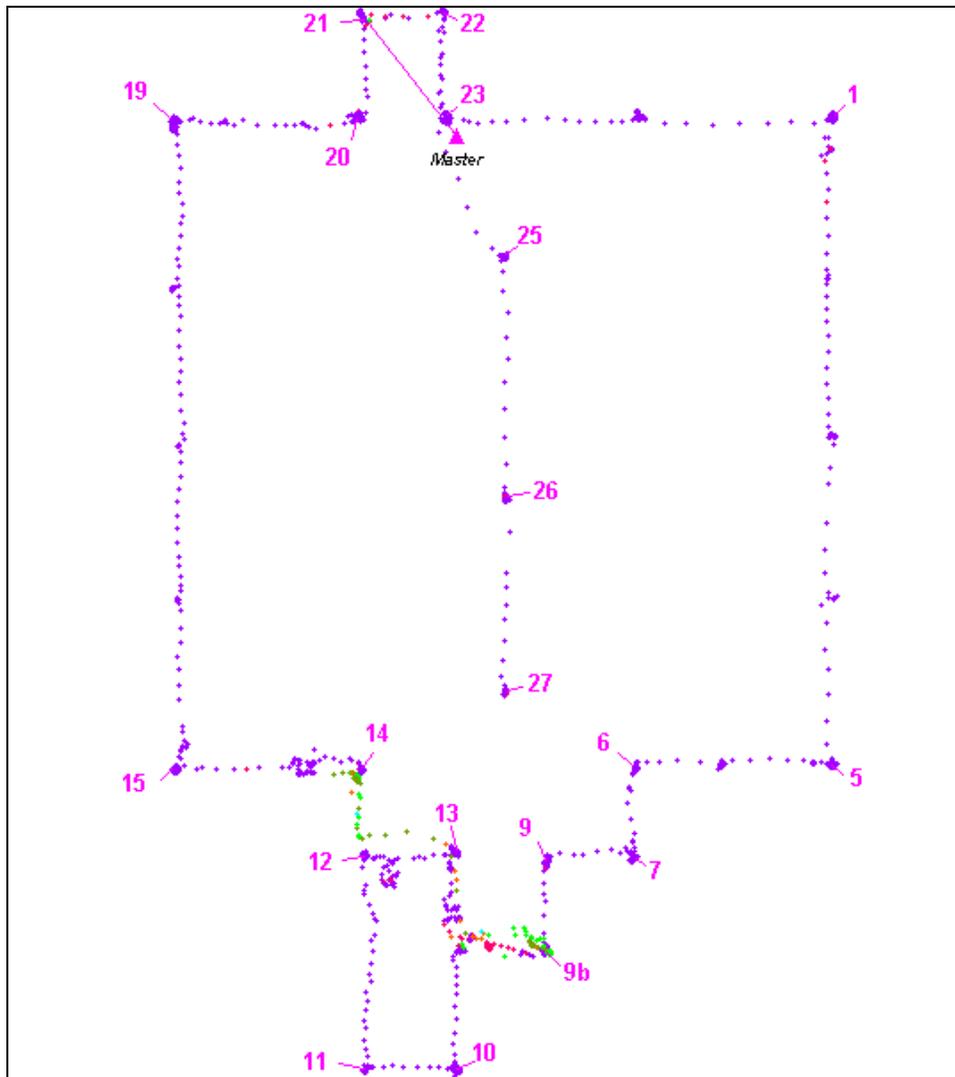
**Figure 24: SFTF Building Roof Truth Contour Generated From Surveyed Data**

Missions were flown over the US Navy SFTF building. GPS data was collected over the facility's roof and used to generate ground truth control points, as seen in Figure 24 below. Lidar data was then compared to the ground truth data.

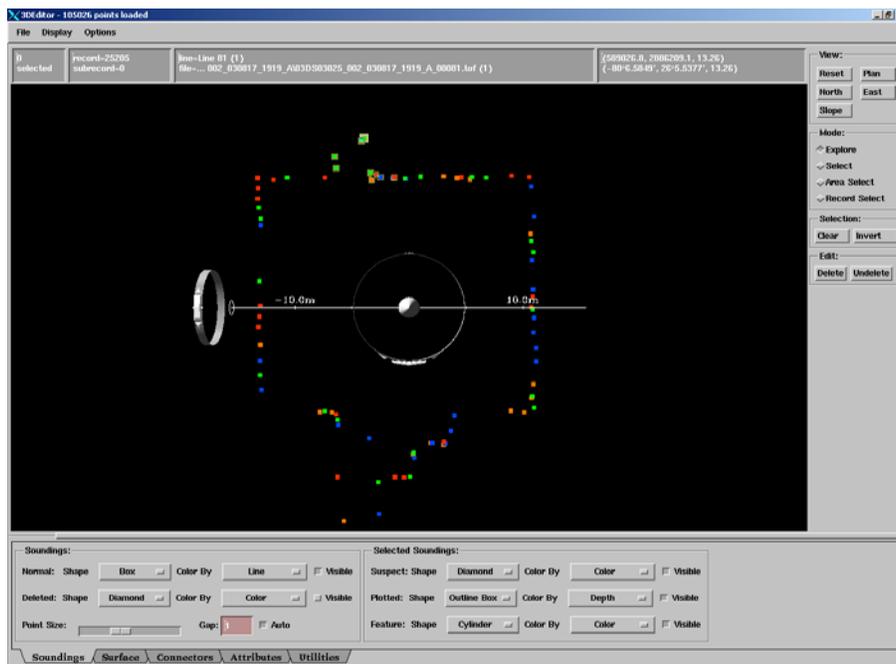
**Figure 26: Flightline Data From The SFTF Building**

Figure 26 on the following page shows data from four flightlines over the SFTF building. Each color is one of an East, West, North and South flightline.

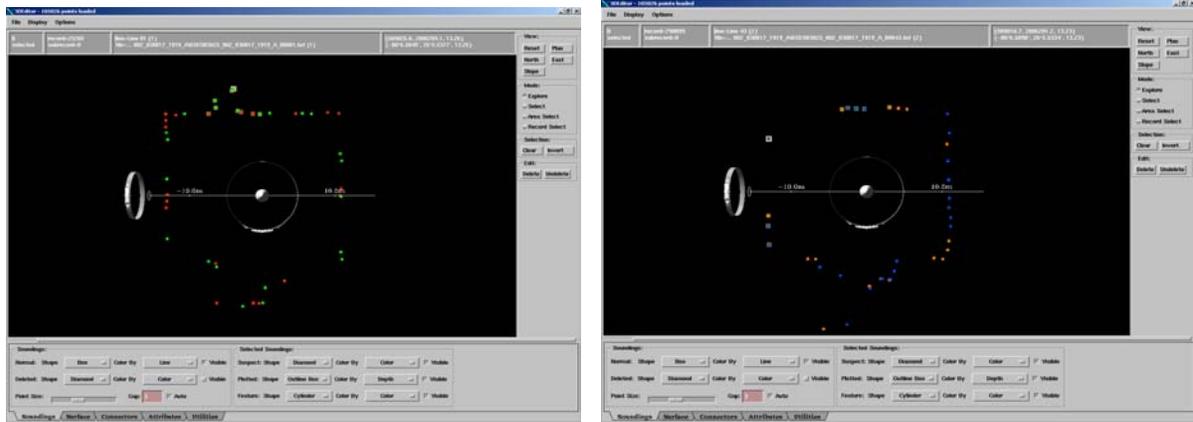
Figure 27: Comparative Flightline Data

Figure 27 on the following page shows the East and West flight data only on the left, and the North and South data only on the right.

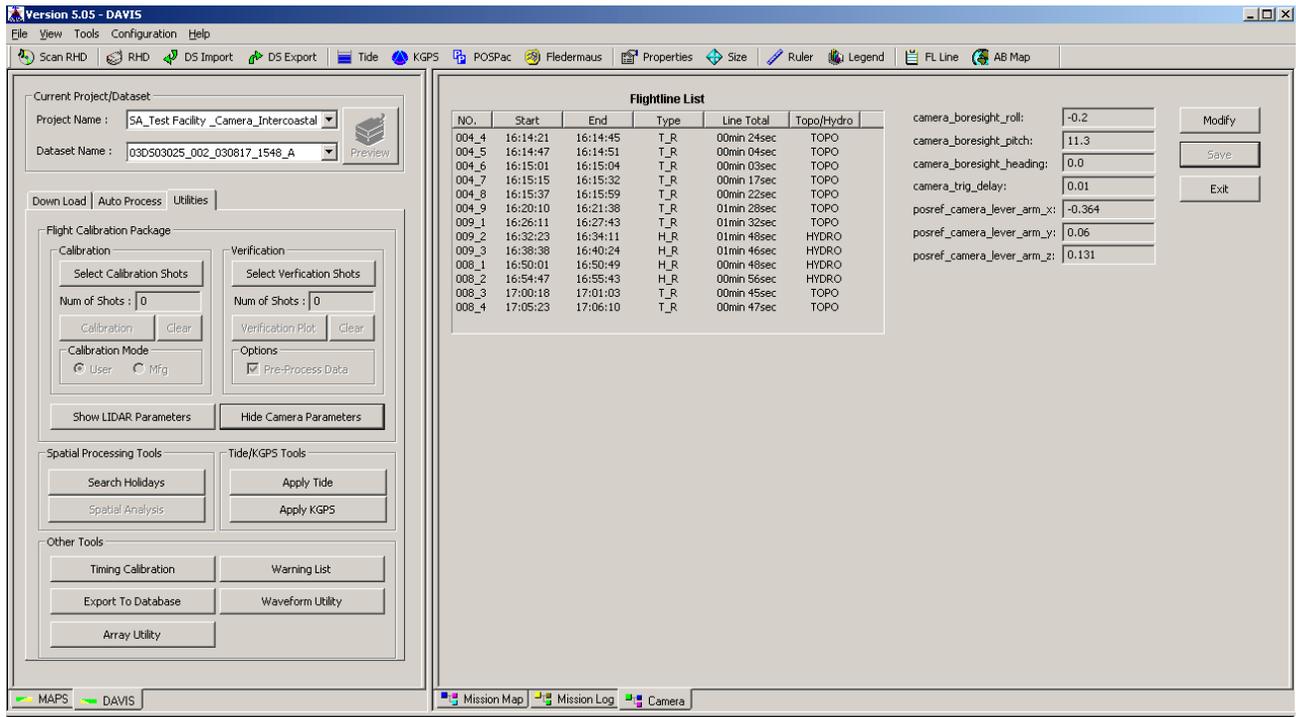
Figure 28: Camera Tab In SHOALS GCS

After the CHARTS data from the SFTF photo target was post-processed, the performance of the boresight angles was tested by entering its values on the Camera tab in the SHOALS GCS (DAVIS → Utilities → Show Camera Parameters (Figure 28 below). Once these values are input, all images in the dataset are automatically updated. There is no need to re-process the data to observe the effect of different values.

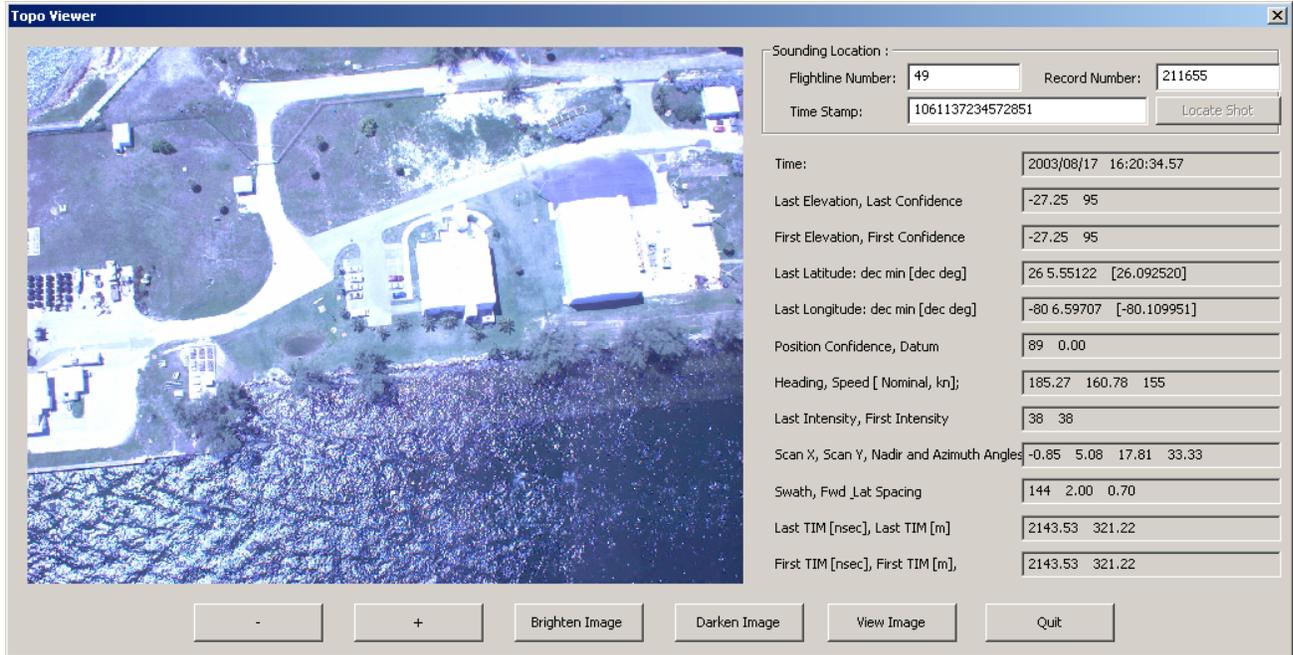
**Figure 29: Topo Viewer Window With Image Of SFTF Building**

In the SHOALS GCS, the image containing the photo target in each flightline was identified (see arrow in Figure 29), and the parameters for the first valid lidar shot associated with the picture were selected to identify the chosen picture (Table 16).

To acquire the CHARTS measured position of the photo target, the ShowImage window (Figure 30) was opened via the View Image button on the Topo Viewer window (Figure 29). The ShowImage window displays the latitude and longitude associated with the mouse cursor position on the status bar.
